CARRIER AIR GROUP ONE HUNDRED TWO
c/o Fleet Post Office, San Fran.

From: Commander, Carrier Air Group ONE HUNDRED TWO.
To : Commanding Officer, U.S.S. BON HOMME RICHARD (CV-31)
Subj: Action Report of Carrier Air Group ONE HUNDRED TWO for period of
30 October 1951 to 30 November 1951
Ref : (a) OpNav Instruction 3480.4 of 1 July 1951.
Encl: (1) Statistical summary of operations from 28 May to 30 November
1951.

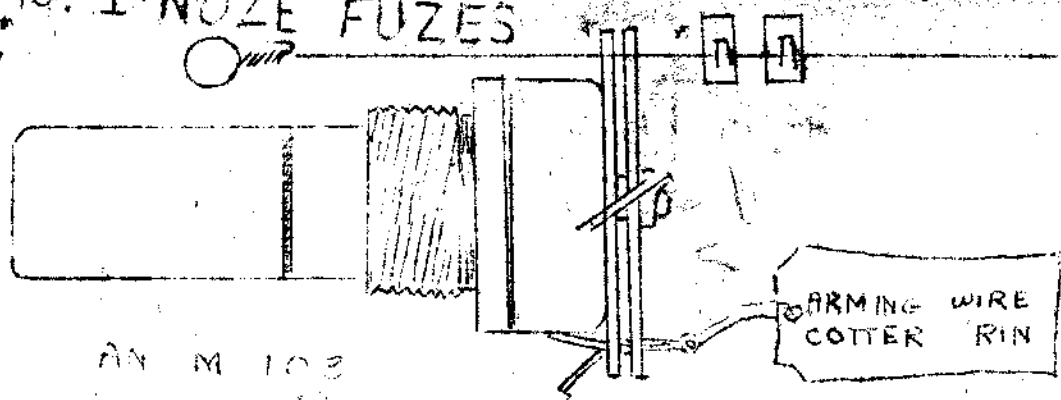
FIG. I NOZE FUZES

4. Another discrepancy is more or less common to all bombing ordnance used in the Korean area and is very apparent in cold weather and night operations when either cold clumsy fingers or lack of good visibility act to lower efficiency. The present methods of arming bombs is unnecessarily tedious and time consuming. This becomes particularly apparent under adverse conditions of weather and visibility and is the one operation that consumes more time between flights and is a particularly critical factor in the meeting of the exacting timing of the flight schedules of this Task Force. It is believed that a little thought given to this problem could result in cutting the bomb arming time short by more than half the present time needed to arm bombs under ideal conditions and even more time could be saved when bombs have to be armed under extreme conditions of night or weather. The following suggestions on possible work-saving modifications could be incorporated by supporting activities in the fuzes now most commonly used and available in the Korean area; (see attached drawings.)

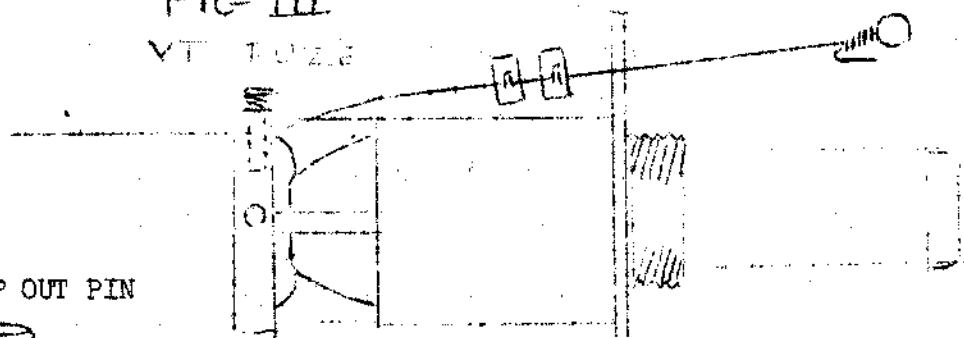
FIG. III
VT FUZE

Fig. 3 and 4. These figures show respectively a representation of any ring type VT fuze with shortened modified arming wires and a modified VT fuze jump-out pin. In this fuze the shortened arming wire used in con-

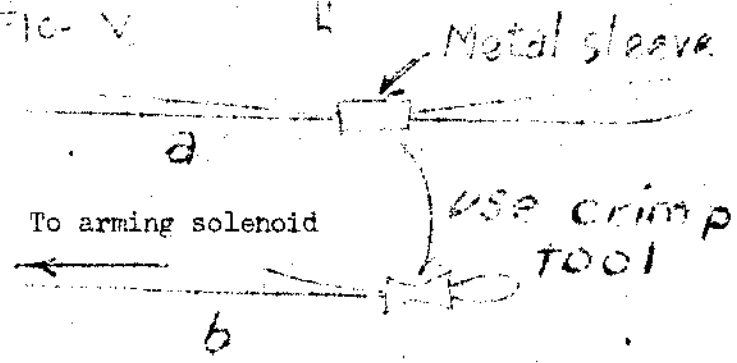
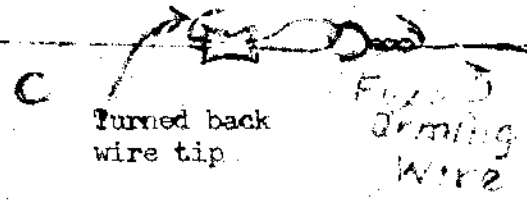
FIG. V

Fig. 5. These figures show progressively how the arming wire coming from the solenoid would be attached to the modified pre-arming wires already installed in the fuzes as described above. Figure 5a shows a straight length of wire over which a metal sleeve has been inserted. Figure 5b shows loop that fastens solenoid arming wire to fuze arming wire with sleeve which is loose enough fitting to be easily slid in place over doubled wire in the dark, holding this loop. A crimp is put in the sleeve with a special plier-like crimping tool. Figure 5b shows an additional safety feature, the turning up of the free end of wire, as an additional precaution against arming loop slipping out and releasing fuze arming wire accidentally.
